Endcap KLM crates power supply problems

Timofey Uglov
KLM meeting 23 Oct 2017

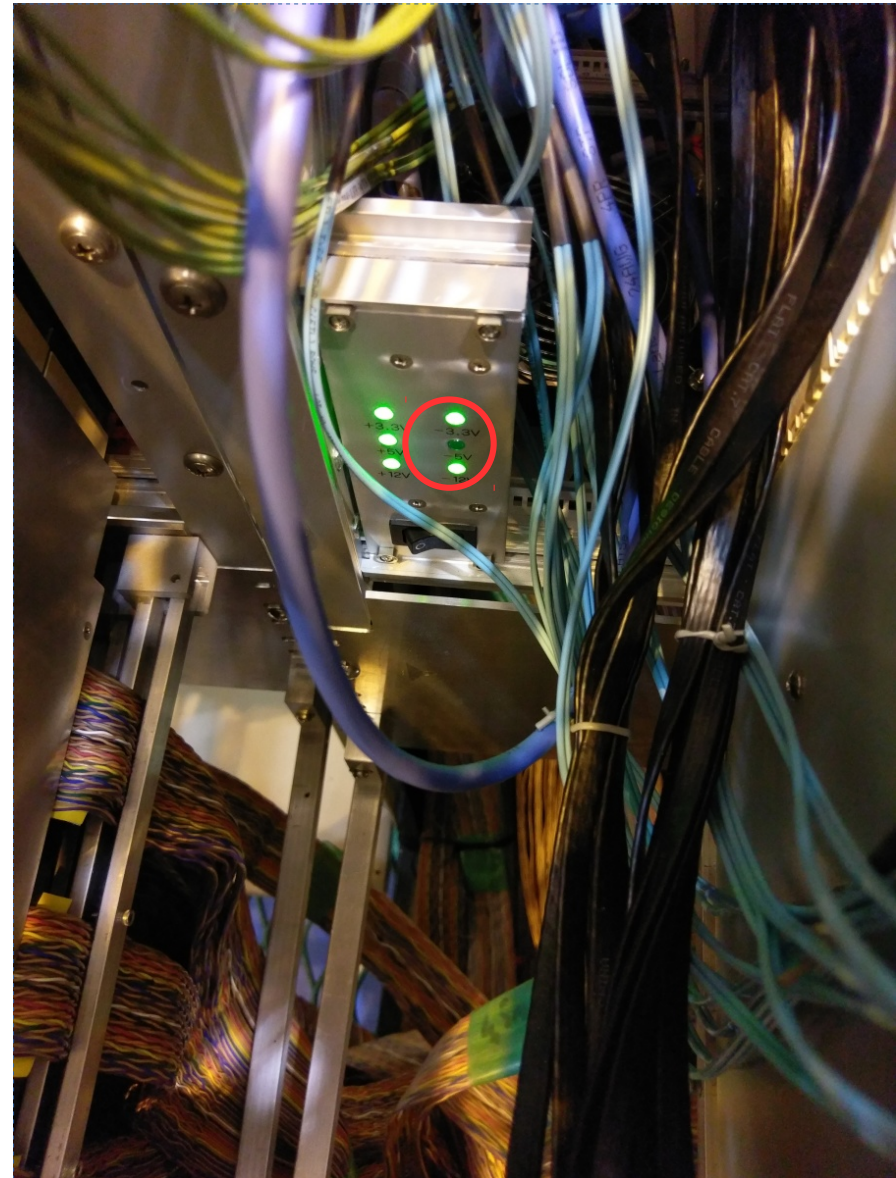
- Forward Endcap crates housing 14 cards suffer from the lack of 5V power
- Backward crates (12 card each) have no such problem
- It is found that there is enough power for 13 cards

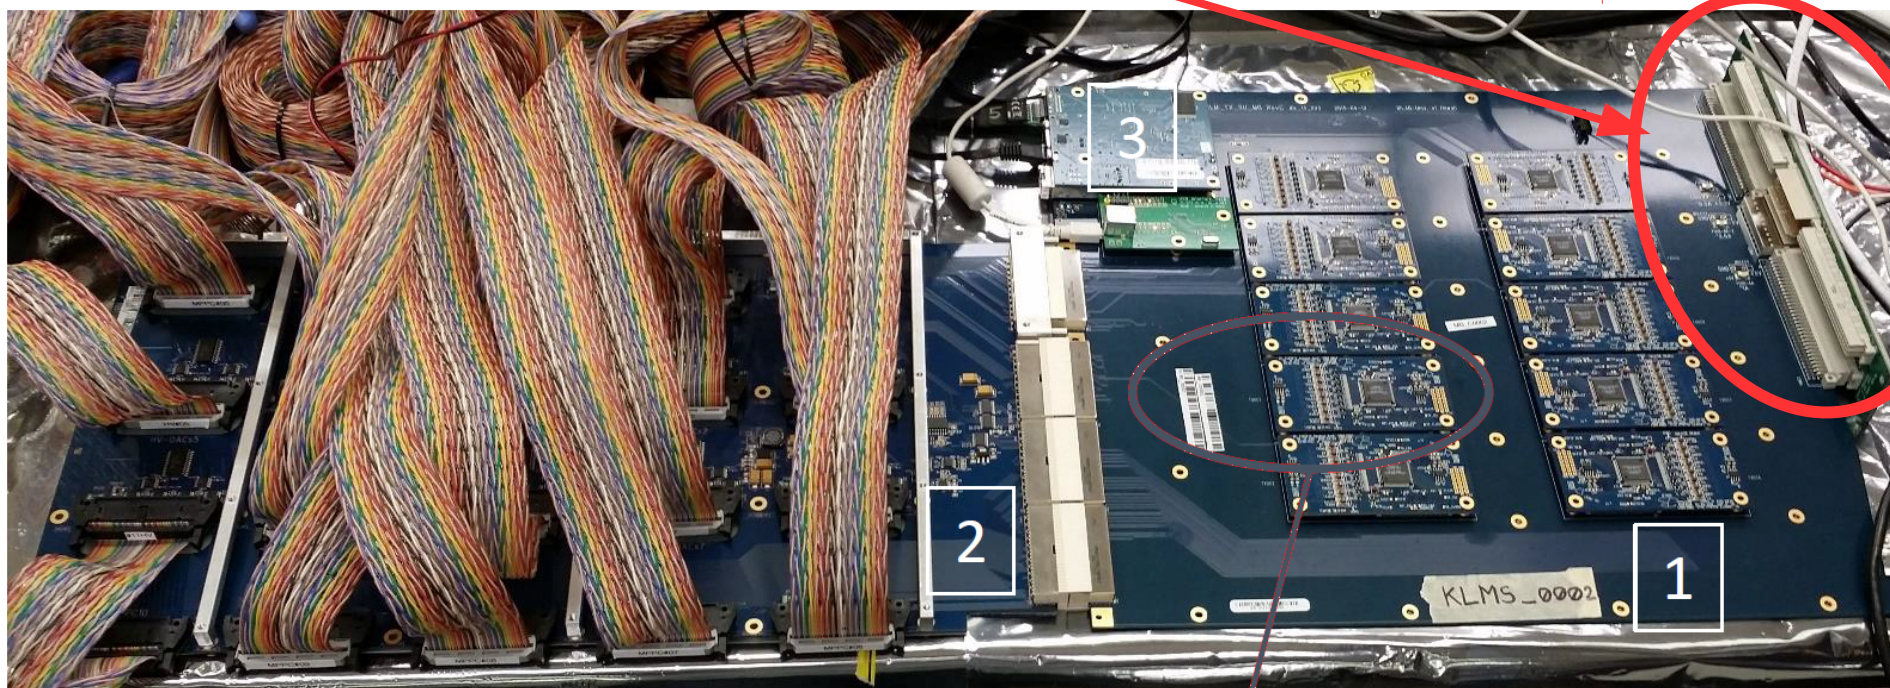
- Duplicates number of FW crates
- Do nothing with safety margins (still $<10\%$)
- Does not solve remote access problem
- Requires mechanical support/frame construction
- Need some place at the top of the endcap doors (under the current crates?)
- Requires external stable PS for the new mini-crates

- Move 2 cards from each forward crate to the 4-slot mini-crates
- Requires the purchase of 2 4-slot mini-crates
- 4-7 slot backplanes are available at Hawaii University
- External PS and no mechanical frame (yet)
